WPC Sound Solution Underlayment

Specifications

No.: XMCCM161201819-2.1

Sample Name 1.5MM HIGH QUALITY EVA ACOUSTIC FOAM

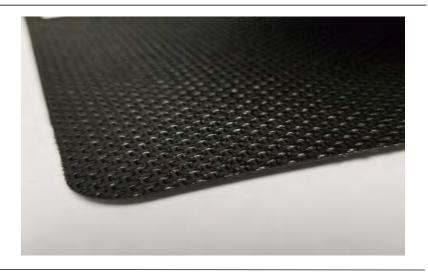
- 1. **Prepare the Subfloor**. Level, repair, and make sure it is free of debris
- 2. **Begin the first row.** Place the roll on the ground with the film side down (facing the subfloor).
 - Note: the overlap of film should be positioned toward the open room and the foam will face the wall.
- Measure and cut accordingly. The plank width will determine how many rows of flooring you will be able to install. When you reach 1ft away from the underlayment, stop and roll out a second row of underlayment.
- Begin the second row. Unroll, measure, and cut. Place the foam side over the top of the film overlap from the previous row. Butt the edges together to create a nice seam, do not overlap.
- 5. **Tape the Seams.** Use industrial tape to adhere the seams together to make a flat & even surface
- 6. **Finish.** Continue installation in sections by repeating the steps above.

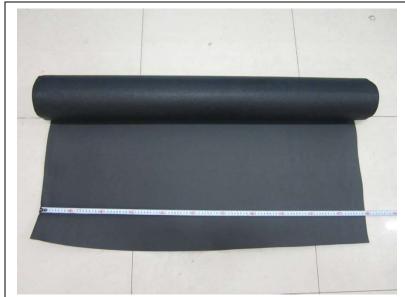
Photo Appendix:

Project description : No decoration of sample surface, sample installation was assembled directly.

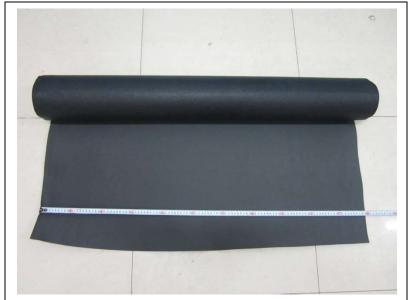
Photo Appendix:

Project description No decoration of sample surface, sample installation was assembled directly.
